HUGHES TOOL COMPANY · AIRCRAFT DIVISION
Culver City, California

Report 285-9-8 (62-8)

HOT CYCLE ROTOR SYSTEM
RESULTS OF COMPONENT TEST PROGRAM

FINAL REPORT

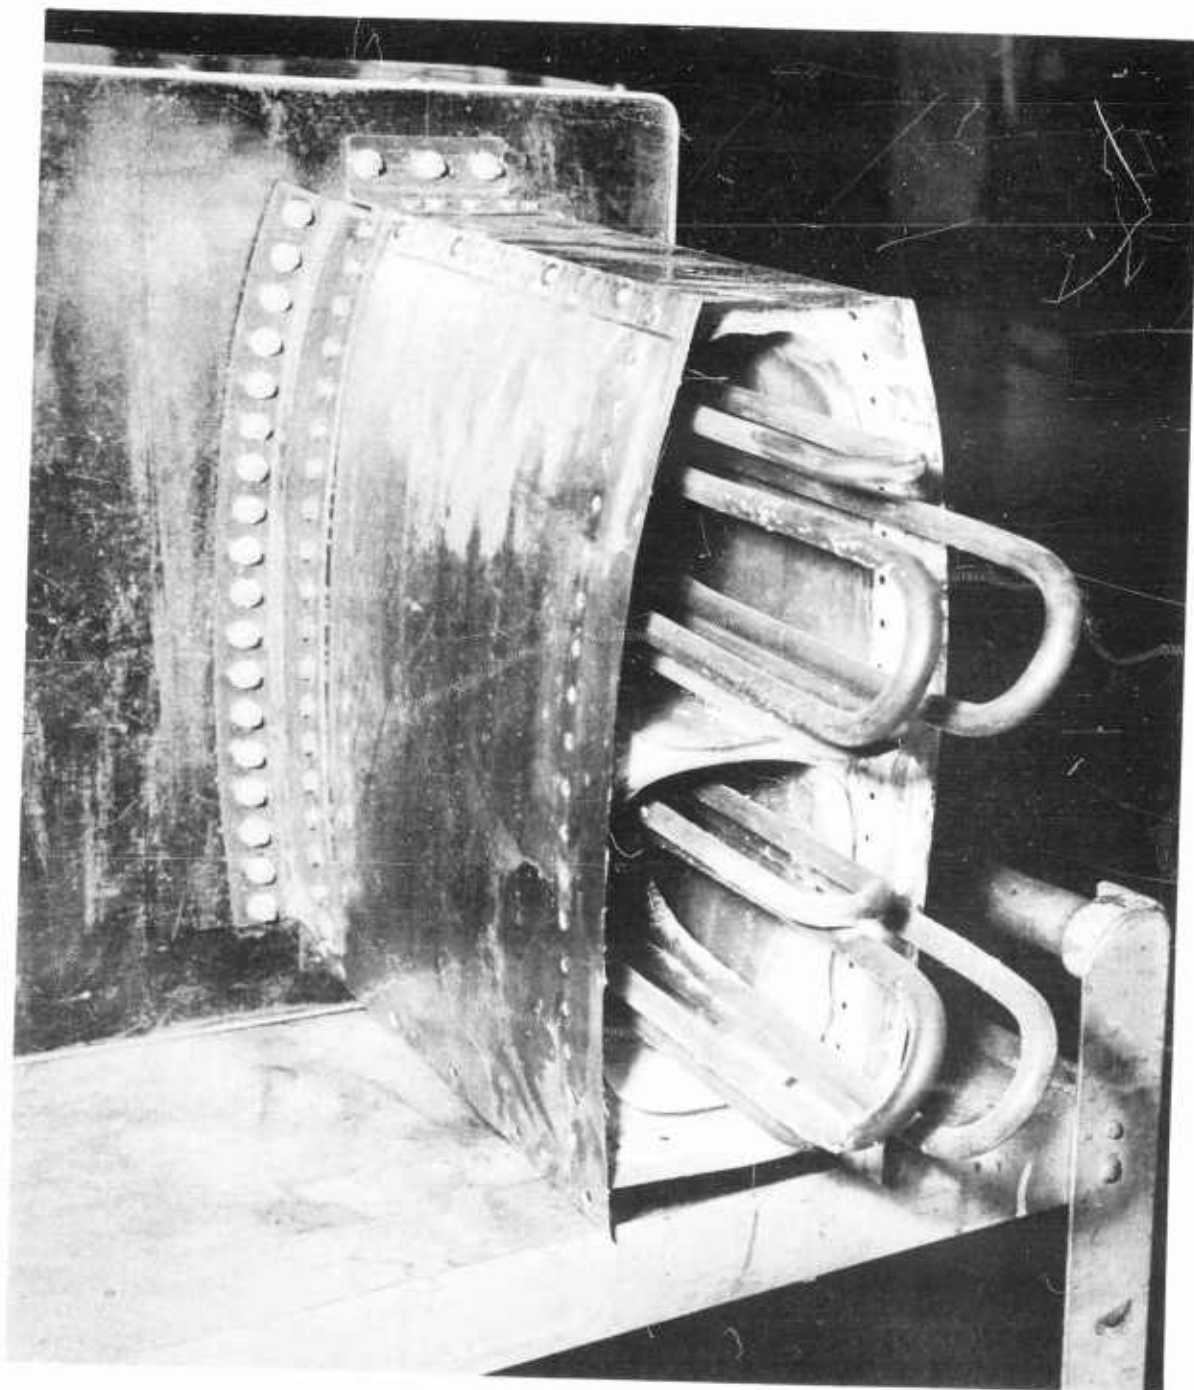
Figure 8-7. View of Joint Area

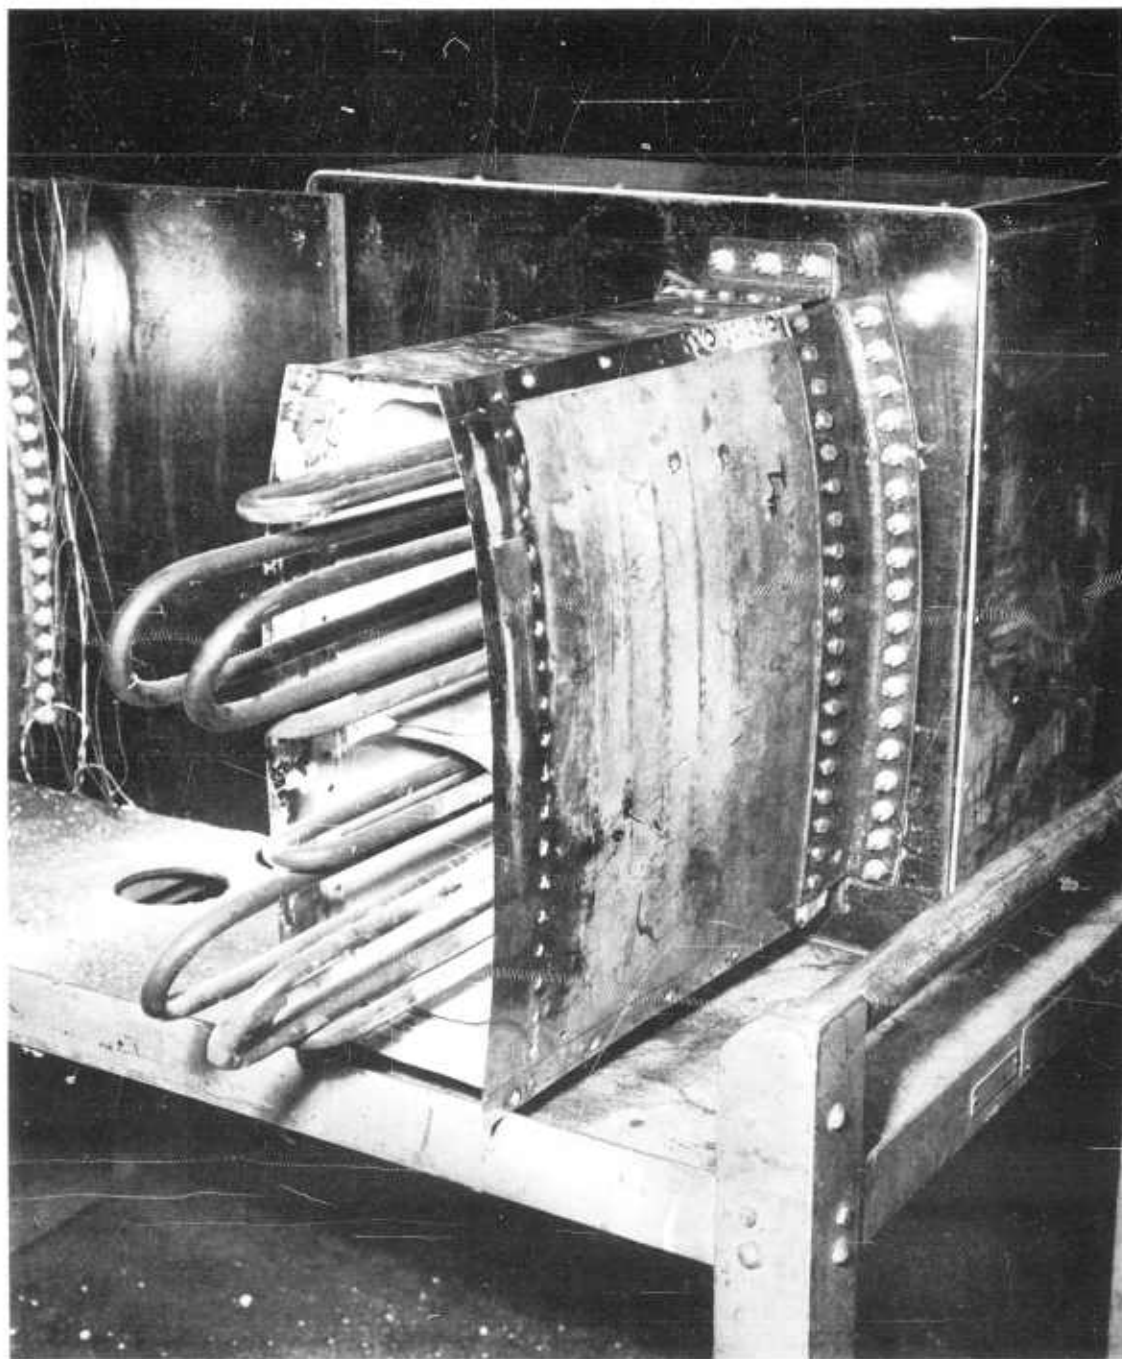
Figure 8-8. View of Joint Area
